402<sup>ND</sup> BATTALION IRAQI ARMY  
HEADQUARTERS BARRACKS  
AL HILLAH, IRAQ

**SIGIR PA-06-077**  
**JANUARY 29, 2007**

SUBJECT: Report on Project Assessment of the 402nd Battalion Iraqi Army Headquarters  
Barracks, Al Hillah, Iraq (Report Number SIGIR-PA-06-077)

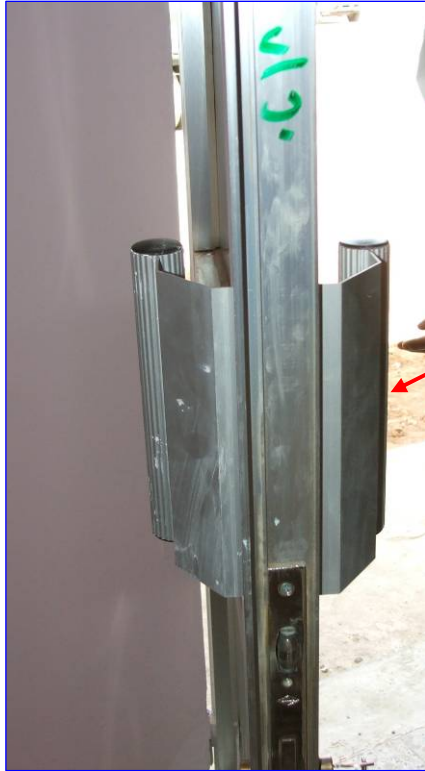
**Site Photo 1. Barracks entrance door cross section**

Although the interior appeared satisfactory, the two entry/exit aluminum doors in the barracks sleeping quarters did not appear to be "good quality," especially for the high traffic expected with a 75-man barracks. Site Photos 1 and 2 provide closer views of one of the aluminum doors and associated hardware. In addition, the doors did not have sweeps. Noticeable gaps were present between the thresholds and bottom of the doors as seen in the door shown in Site Photo 3.

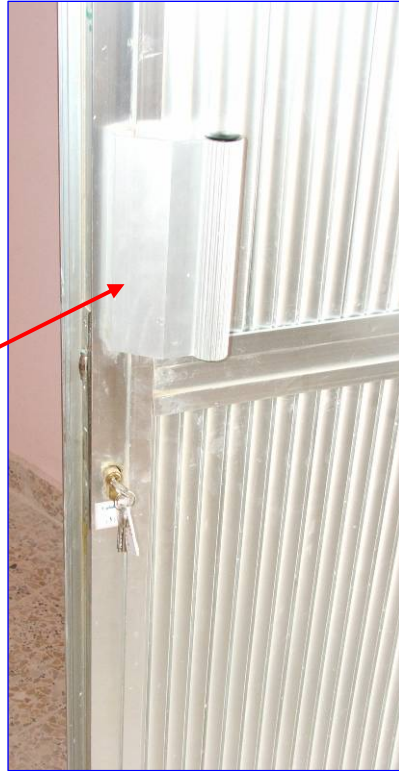
**Site Photo 2. Barracks entrance door**

In addition, we also identified the poor quality aluminum doors in the barracks sleeping quarters. As with the ablution buildings, considering the heavy traffic expected in a 75-man barracks, a higher quality type door was needed. Another concern is that during a strong windstorm, the aluminum doors may fly off.

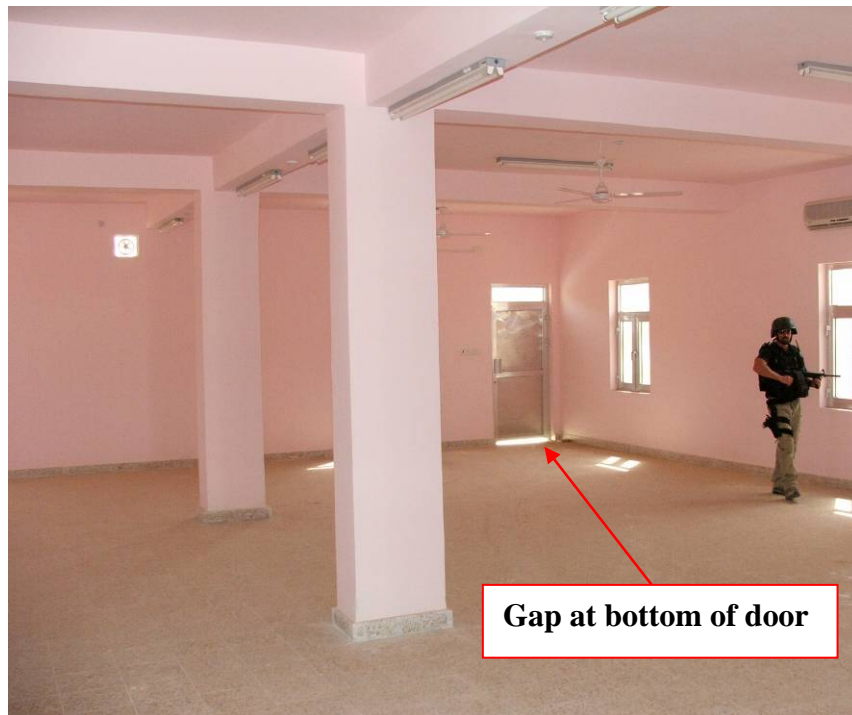
**Site Photo 3. Interior of one of the two barracks**

**Gap at bottom of door**

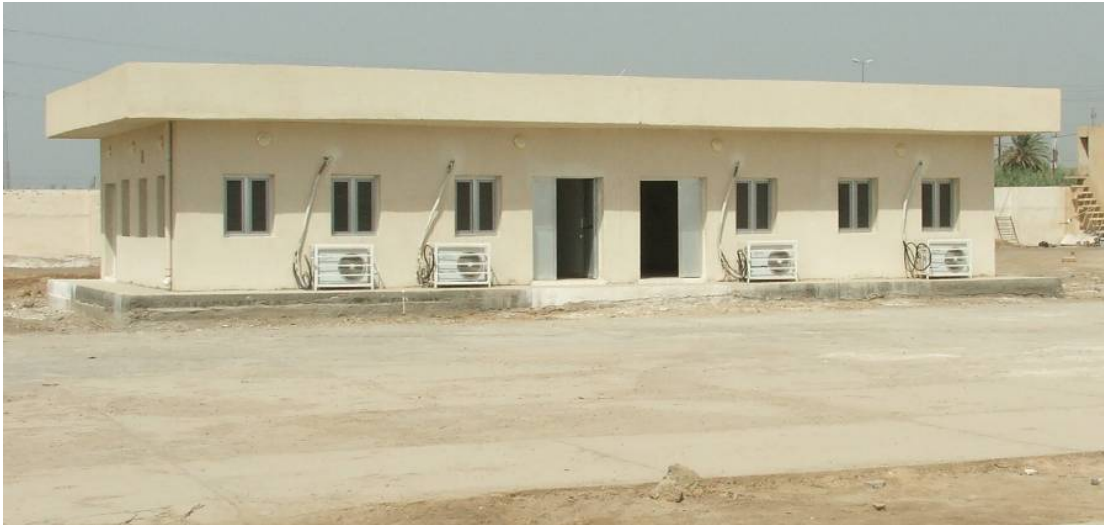
**Site Photo 4. Classroom building with four classrooms**

The architectural floor plan showed a rectangular building containing four equal sized classrooms, each approximately 4.25 x 8.35 m with an exterior entrance door for each classroom. The interior finishes were the same as the barracks buildings, but the design drawings did not include any information about the interior finishes. We observed plastered and painted walls and ceilings, with mosaic floor tile in the interior and a plastered and textured finish on the exterior. Each room contained aluminum frame windows and an aluminum entrance door. Site Photo 4 shows the exterior of the classroom building.

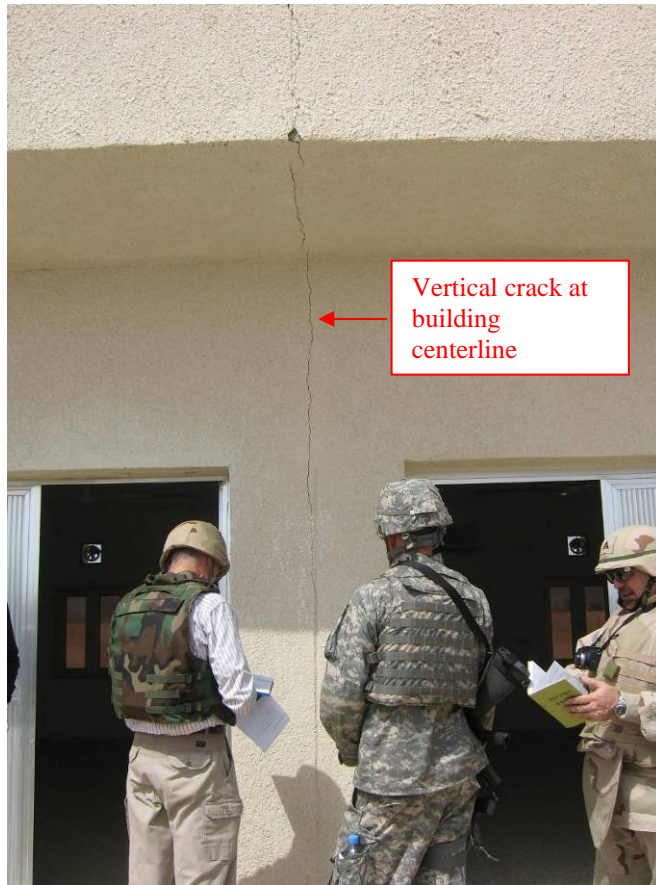
The design included two, two-ton HVAC units in each classroom augmented with a ceiling fan, and two wall exhaust fans, which we verified as installed. Overall, the building appeared satisfactory, except we did observe a noticeable crack in the exterior near the center of the building. The crack ran on both sides of the building, beginning at the sidewalk and continuing vertically in the wall and along the soffit and parapet as shown in Site Photos 5 and 6. The structural design for the building shows in the center of the building, a 480 mm masonry wall consisting of two, side by side masonry wall sections, each 240 mm thick. The design also shows the dual masonry walls supporting two adjoining bond beams, each 250mm thick. The design does not show any tying mechanism between the dual masonry walls or connecting reinforcing steel or dowels in the two concrete beams. Based on this design and the presence of the vertical crack along the building centerline, it appears there should be an expansion joint in the center of the building to allow for the differential movement of each side of the building.

**Site Photo 5. Vertical crack in front side of classroom building exterior**

In general, the construction appeared to meet the standards of the Statement of Work and design. The inspection team did not observe significant deficiencies during its visit to the project site. However, the noticeable crack in the classroom building exterior requires further assessment by the U.S. Army Corps of Engineers Gulf Region South Babil Resident Office and remedial action taken to correct the problem. In addition, since the water tank design lacked sufficient detail, the water tank construction should also be assessed for structural adequacy. The U.S. Army Corps of Engineers Gulf Region South Babil Resident Office provided adequate oversight to ensure the requirements of the Statement of Work and the design were met.

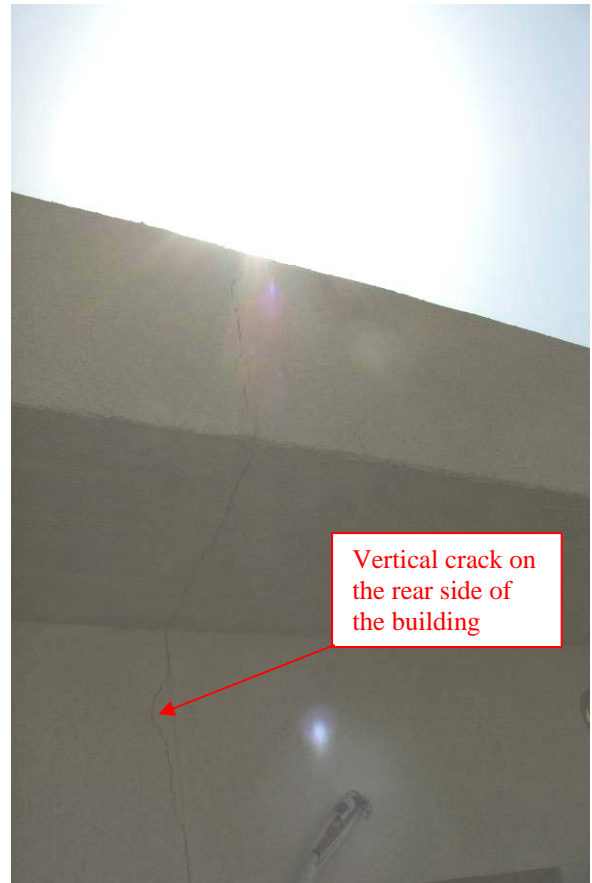
**Site Photo 6. Vertical crack in opposite side of classroom building exterior**

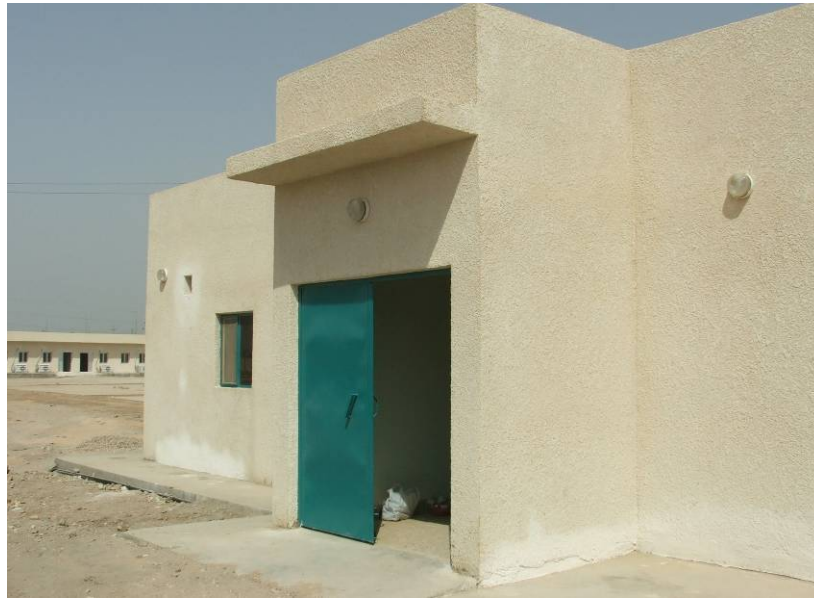
**Site Photo 7. Exterior of the medical clinic**

The medical clinic was designed as an addition to an existing medical clinic with a covered breezeway to connect the addition to the existing clinic. The building we inspected was a stand-alone facility without a connecting breezeway; however, in accordance with the design, it did contain an entrance area and three rooms: a patient ward, a storeroom, and a laboratory. Site Photo 7 shows the front side of the medical clinic, including the main entrance.

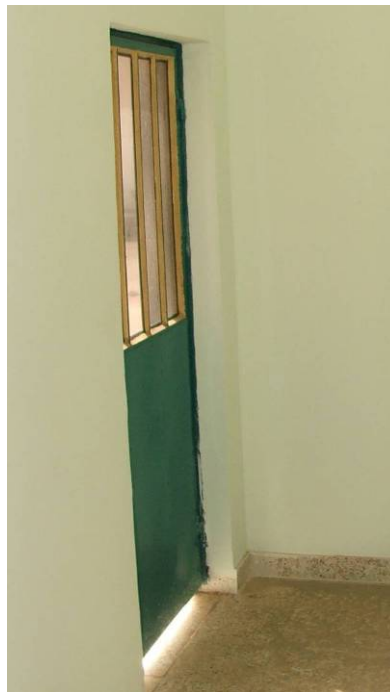
**Site Photo 8. Medical clinic exterior door**

The SOW required a plastered and painted finish for the ceilings inside the medical clinic and ceramic tile walls and floors for the ward area and the laboratory. We found ceramic wall and floor tile in the laboratory, but the patient ward room contained plastered and painted walls and ceilings, and mosaic floor tile. We found no deficiencies with the quality of workmanship in either room. The other required interior finishes included fluorescent lighting, metal windows, wooden interior doors, and metal exterior doors, which we observed in our inspection. Although they appeared to be installed correctly, we did observe a noticeable gap at one exterior door location between the threshold and the bottom of the door as shown in Site Photo 8.

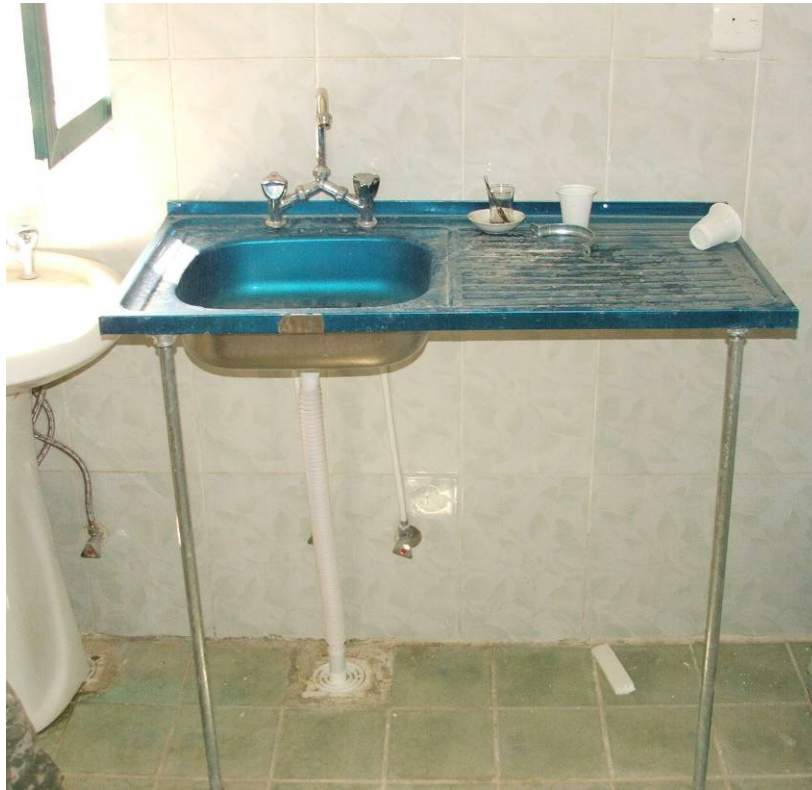
**Site Photo 9. Medical clinic exterior sink**

The plumbing design drawings showed a double sink in the laboratory and a single sink and a wash basin in the patient ward area. We found one pedestal style wash basin in the laboratory and one in the patient area. A single sink, shown in Site Photo 9, was installed in the laboratory. The USACE PE told us this sink was substandard and would be replaced prior to final acceptance of the building.

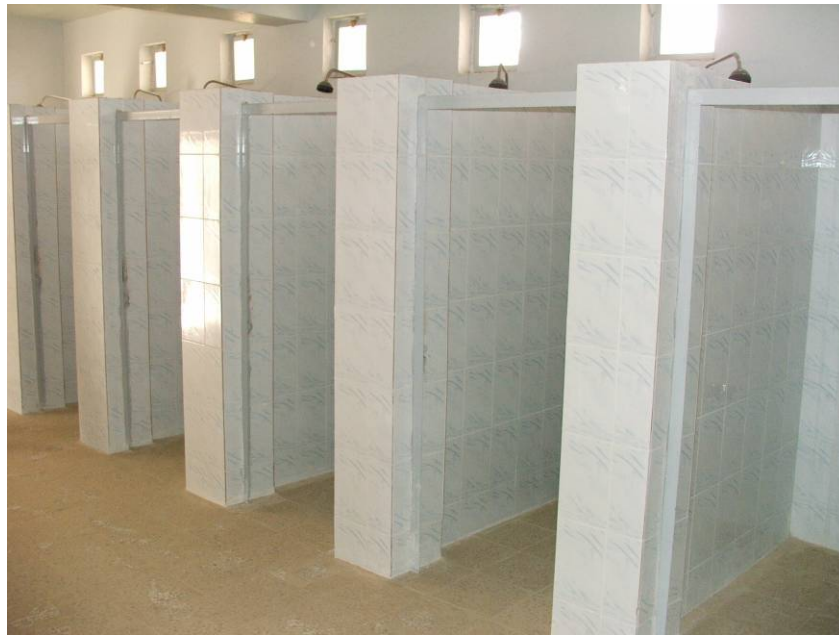
The project scope included construction of two single story ablution buildings, each one near one of the new barracks. The design for each 8 x 10 m building included seven individual showers, eight water closets, and a hand washing station with eight faucets, and three electric water heaters, which we verified during our inspection. The SOW required a sand-cement exterior wall finish. The SOW also required the contractor to plaster to a smooth finish and paint interior walls and ceilings, and to install mosaic floor tile. During our inspection, we observed plastered and painted ceilings, and mosaic floor tiles. The contractor had also installed ceramic tile to a height of about six feet along the walls as shown in Site Photo 10. We did not find any noticeable deficiencies associated with the ablution building interior and exterior construction. However, we did observe what appeared to be low quality plumbing fixtures (shower heads, water supply lines, faucets, drain covers, etc.) installed in the showers, wash stations, and water closets. Site Photo 11 shows the type of plumbing materials used in the water closets, which includes flexible water hoses, plastic supply tanks, and plastic tubing from the tank to the toilet.

Considering the heavy usage the ablution buildings will receive, this type of low quality material will pose continual maintenance problems for the Iraqi Army.

**Site Photo 10. Ceramic tile finish on shower walls in ablution buildings**

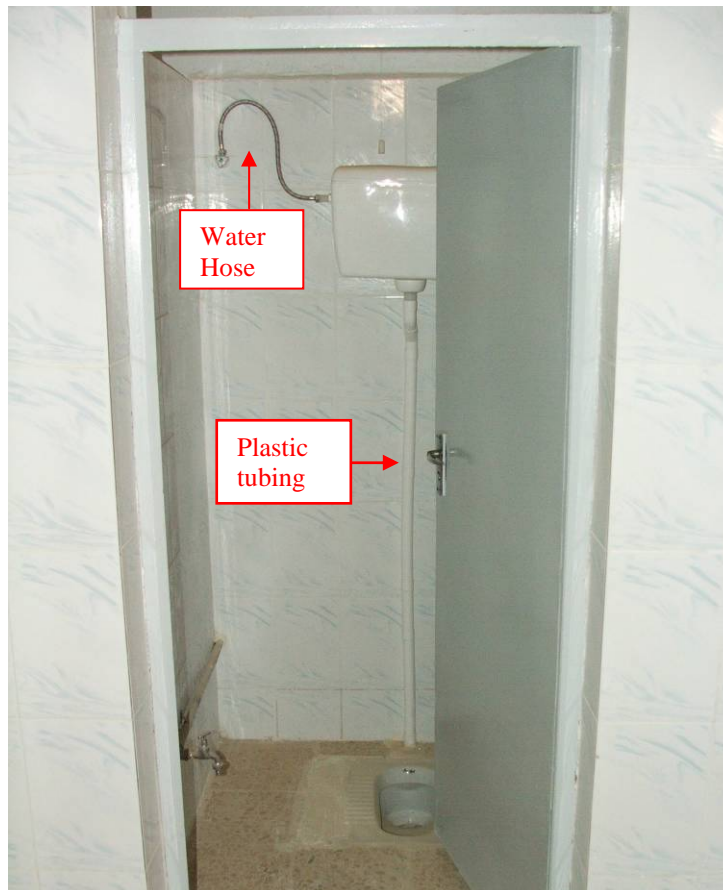
**Site Photo 11. Water closet in ablution building**

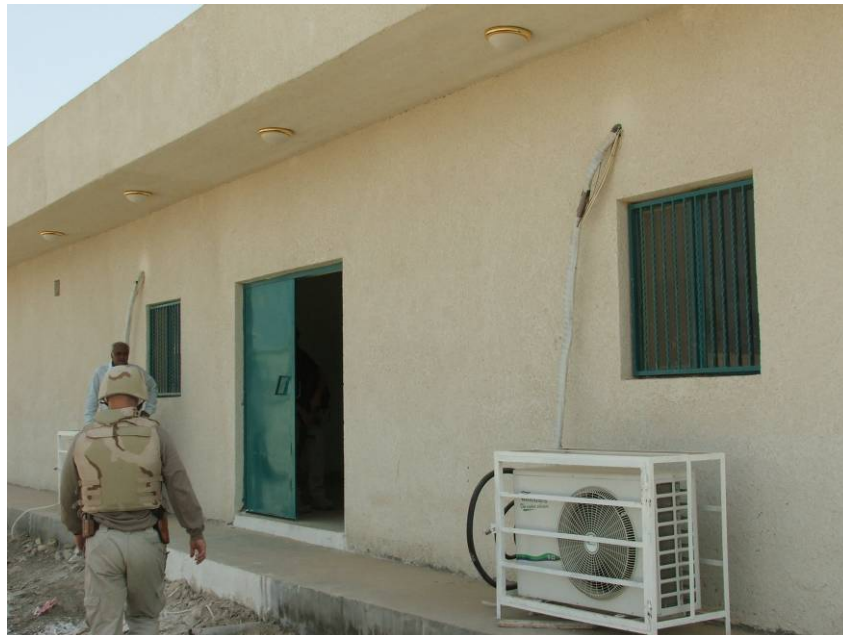
**Site Photo 12. Exterior view of armory entrance**

We found the armory constructed as designed with no significant deficiencies. We also observed the contractor had installed mosaic tile in every room over the concrete floor slab. Site Photo 12 shows the front of the armory building including, the steel entrance door, windows with metal grilles, and one of the two-ton HVAC units.

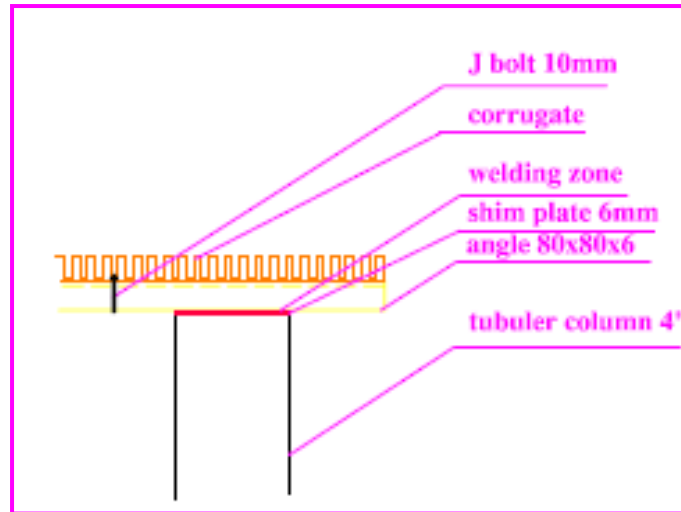
**Figure 1. Design detail for covered parking (sunshade)**

The design detail for the structural frame supporting the corrugated roof sheeting (Figure 1) showed an 80 x 80 x 6 angle supporting the roof sheeting. No units were provided for

the angle, although it is assumed the dimensions are in millimeters. Figure 1 also shows the angle welded to a shim plate at the top of the column. There were no details provided on the type or size of weld or the type and thickness of the corrugated roof sheeting. The design also did not show any lateral cross bracing perpendicular to the angle support shown in Figure 1.

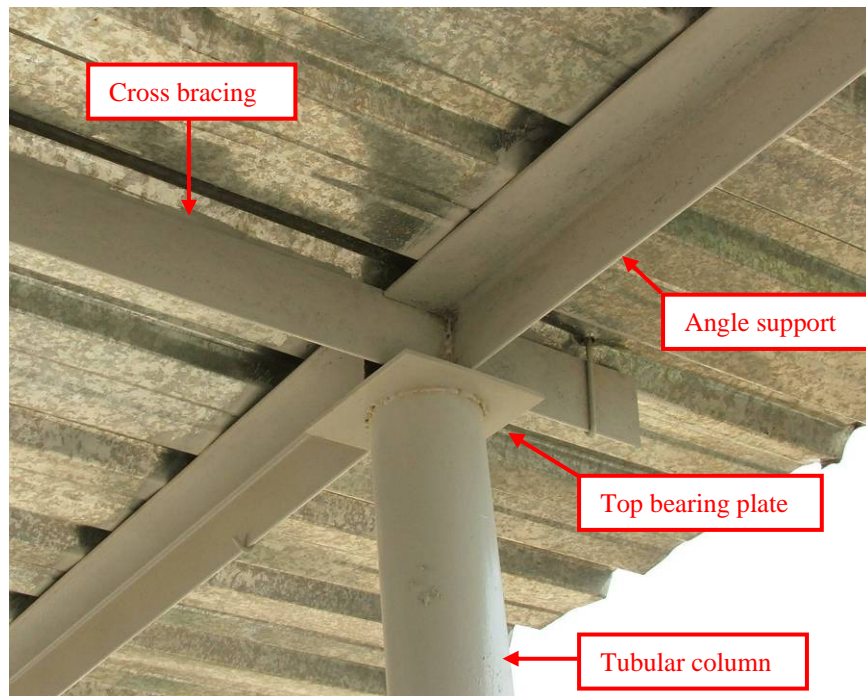
**Site Photo 13. Typical column support for covered parking (sunshade)**

The assessment team inspected both parking sunshades and found no significant deficiencies based on the SOW requirements and the design. We did note that many of the four inch tubular columns consisted of spliced sections of pipe welded together to form one tubular column. The design did not provide any details as to whether welded pipe columns were allowed.

Site Photo 13 shows the actual welded angle connections at the bearing plate (i.e., shim plate) at the top of each tubular column. Also shown is the lateral cross bracing. The roof sheeting material appeared to be a thin gage sheet metal, connected to the frame with J-bolts as depicted in Figure 1.

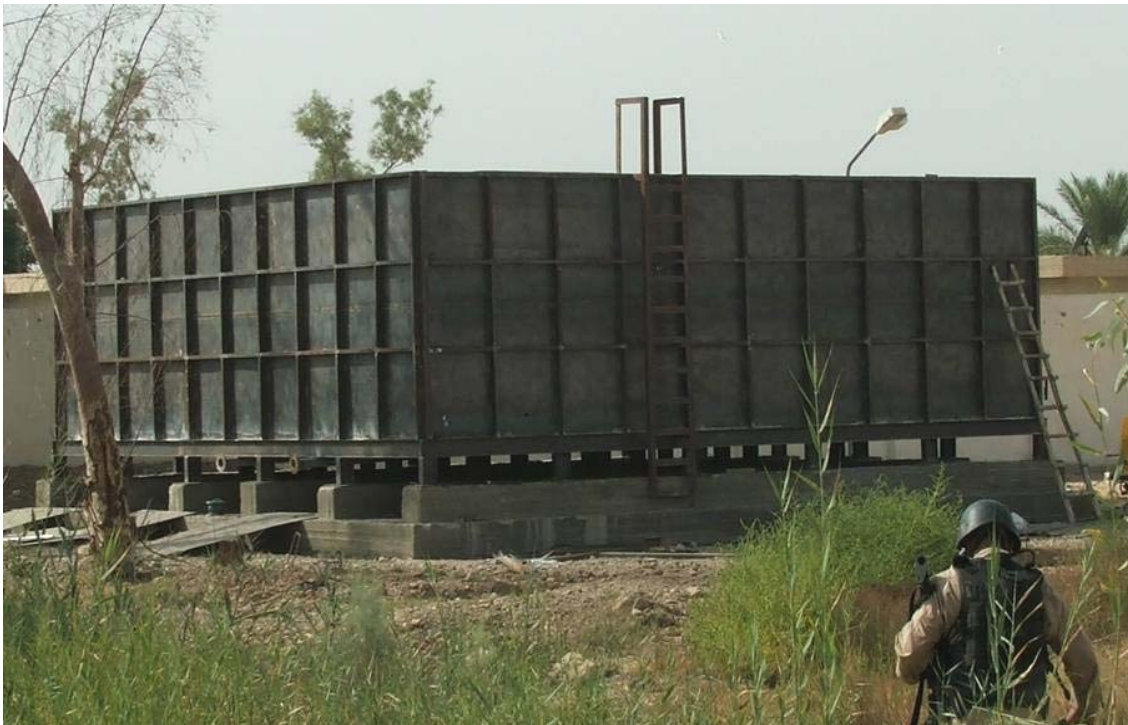
**Site Photo 14. 300 m<sup>3</sup> water storage tank under construction**

The SOW required a 300 m<sup>3</sup> (10 x 10 x 3 m) water storage tank supported on a concrete foundation and a structural steel frame. However, the four design drawings lacked sufficient details, and provided only a conceptual layout of the tank structural frame. There were no details on the sizes of the structural support members, or the thicknesses of the tank's bottom, sidewalls, and cover. Further, there were no connection details showing how the tank's bottom, sidewalls, and cover are interconnected, nor were there any details showing the connections between the vertical structural supports and the tank walls.

During our assessment, we observed a partially completed water tank as shown in Site Photo 14 that met the size requirements for a 300 m<sup>3</sup> tank. The tank was supported by a concrete foundation and structural steel frame. The tank sides consisted of steel plate, spot-welded to the structural steel supports. Site Photo 15 shows the spot welding along one side of the tank. The steel plates appeared to be approximately 0.25 inches thick.

Given the lack of details in the design, the assessment team could not determine whether the water tank construction met the standards of the design. However, we were concerned with the quality of the spot welds and if there was sufficient steel plate thickness to withstand the hydrostatic pressures associated with a fully filled 300 m<sup>3</sup> water tank. We discussed our concerns with the USACE Babil RE and PE. We also recommended the USACE GRS structural engineer assess the adequacy of the water tank construction.

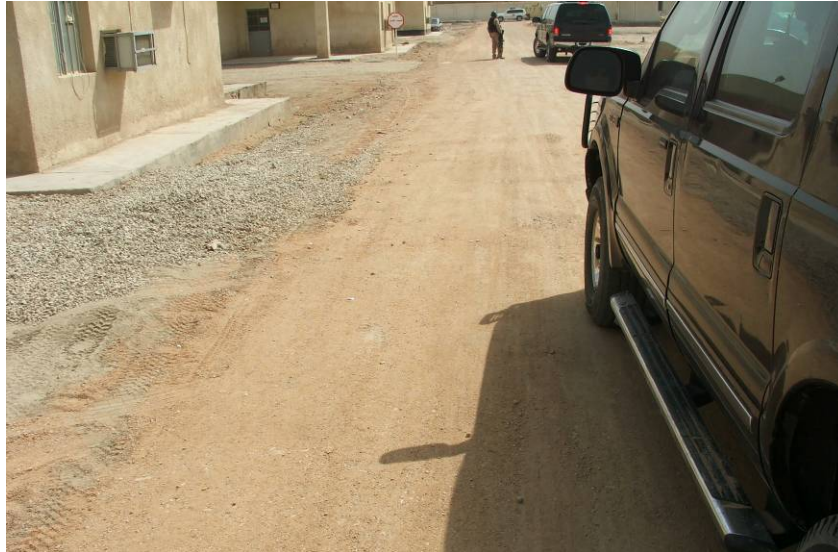
observed compacted subbase material in place at various locations on the compound. Site Photo 16 shows one of those locations in front of the medical clinic. The USACE PE indicated the contractor would construct the required amount of paved surfaces specified in the SOW (i.e., 2,540 m<sup>2</sup>).

The surface of the subbase appeared to consist of compacted granular material. Although we could not measure the depth of the subbase, the sections of new roadway we observed appeared adequate.

**Site Photo 16. Compacted subbase material for one of the new roads under construction**

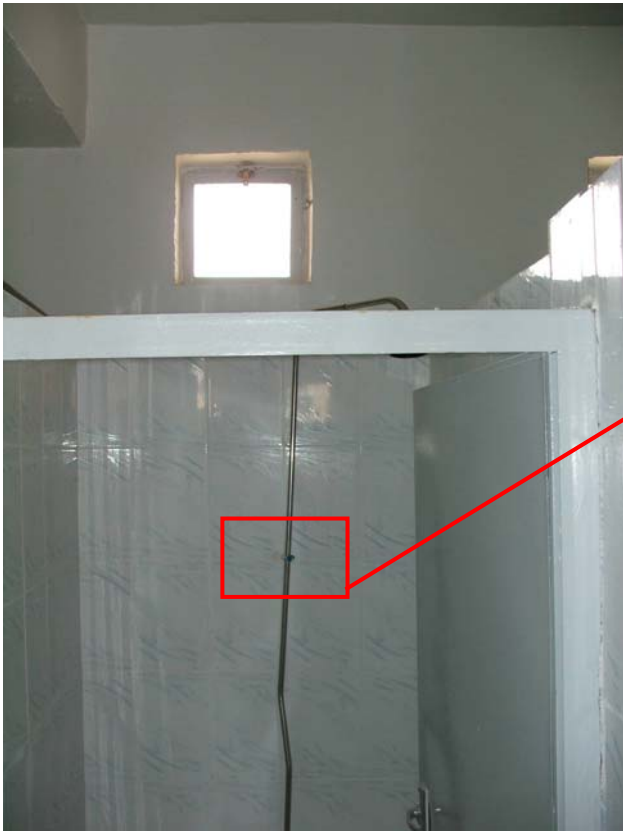
Earlier in this report, we identified potential sustainability issues with the low quality plumbing fixtures in the ablution buildings. For example, the plumbing materials used in the water closets included flexible water hoses, plastic supply tanks, and plastic tubing from the tank to the toilet; while in the showers, the water faucets are susceptible to breaking off and the thin metal tubing to the shower head is connected to the wall with a one screw clamp (Site Photos 17 and 18). Over time, the clamp will dislodge from the wall and the shower water pipe will remain unsupported. Considering the heavy usage the ablution buildings will receive, the low quality material will pose continual maintenance problems for the Iraqi Army.

**Site Photo 17. Shower fixture in the ablution building**

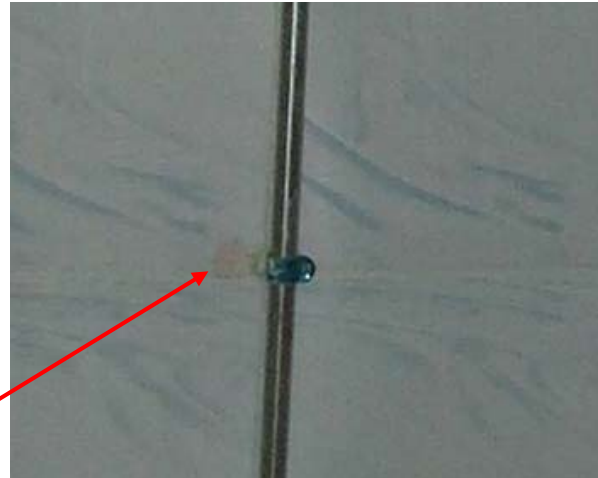
**Site Photo 18. Close up view of clamp**
